**Region:  
Otways**

**Legal  
Number:  
LEGL/93-  
48/1**

**Plantation:  
Webster Hill**

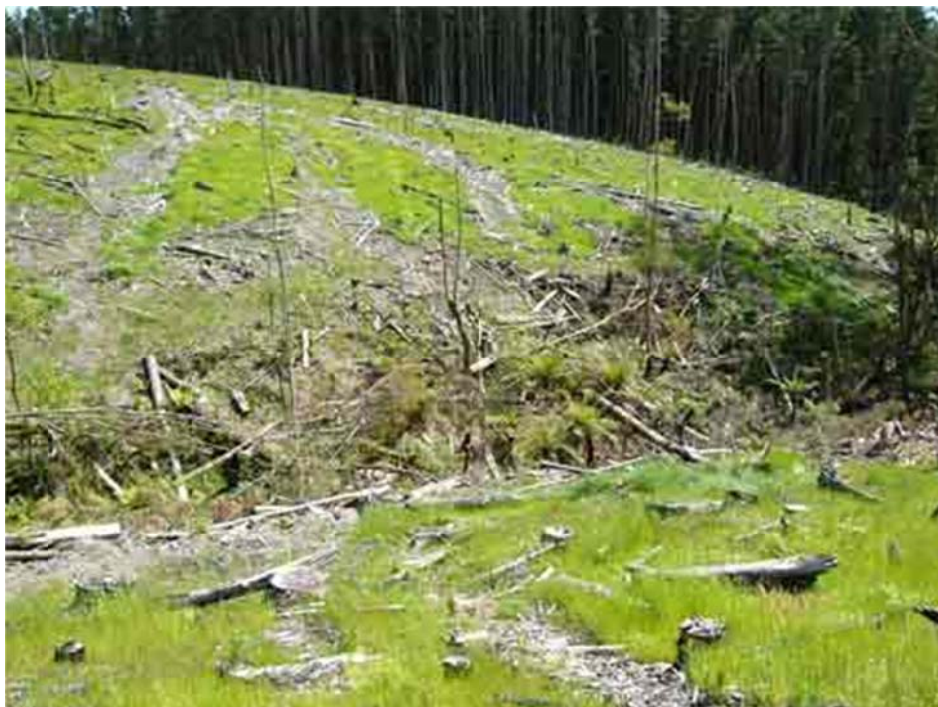
*November 2004: Photo taken several months after logging. Note lack of buffers on tributary of Lardners Creek East Branch. Note emergence of grasses which will most likely be aeriually sprayed. Is this a sustainable practice in a proclaimed water supply catchment?*

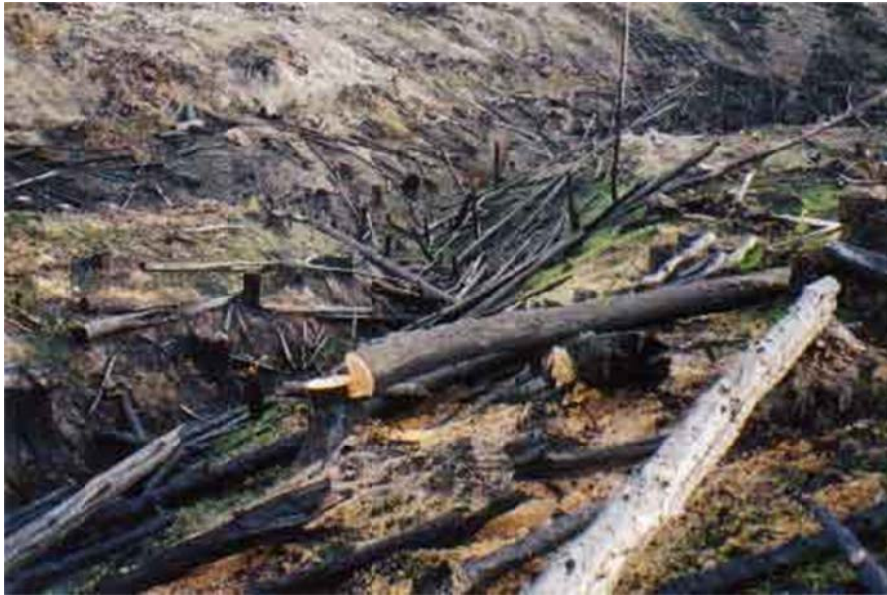
*June 2002: Torched tributary of Lardners Creek East Branch. Is this world's best practice in a Proclaimed water supply catchment. Is Barwon Water monitoring this site? Note chainsawed remnant trees.*

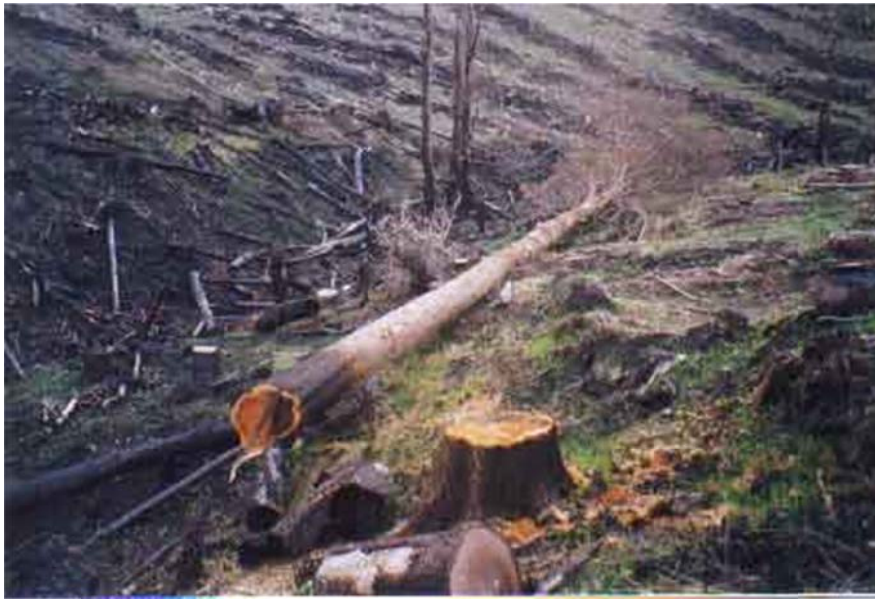
*June 2002: Chainsawed non plantation tree in buffer zone of Lardners Creek East Branch.*

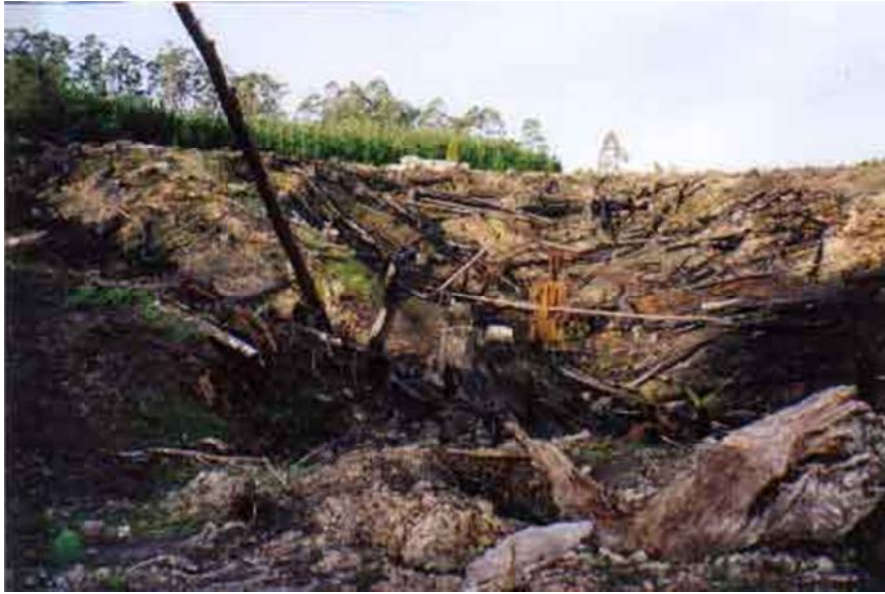
*June 2002: Bulldozed and totally trashed tributary of Lardners Creek East Branch. Is this any way to treat a catchment that supplies drinking water for people?*

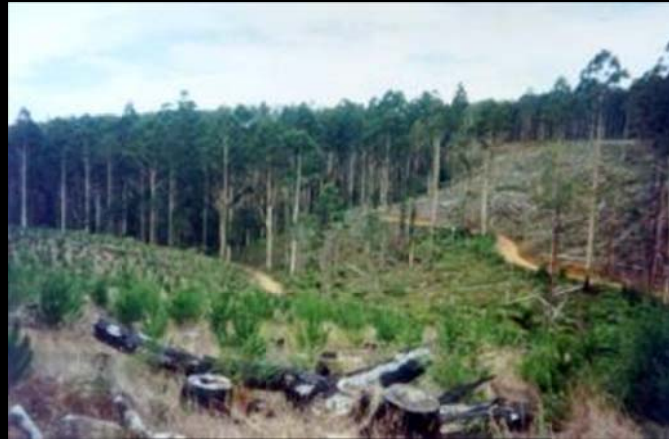
93-48b Feb 01: Native vegetation near Sayers Track. DNRE/Hancock licence area. These trees can possibly be logged under agreement with the State Government..

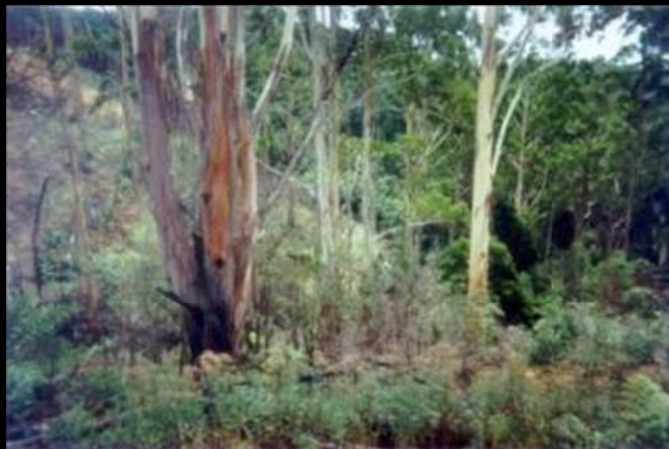
93-48c Feb 01: Native vegetation in plantation - Asplin Creek Trib/Gellibrand River. Water from this plantation supplies over 50,000 people with drinking water.

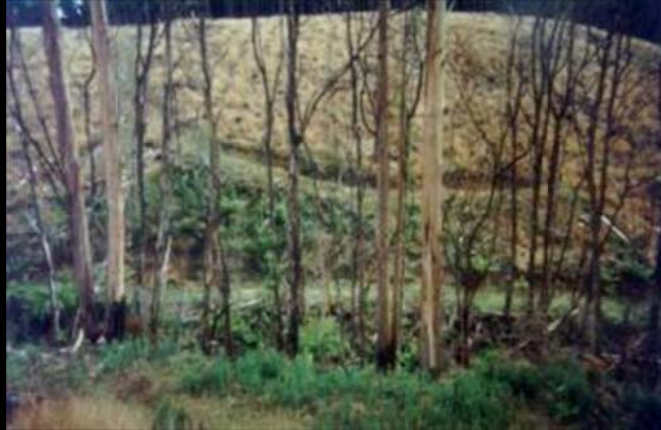
93-48d Feb 01: Roading near gully of Asplin Creek Trib/Gellibrand River. Water from this plantation supplies over 50,000 people with drinking water.

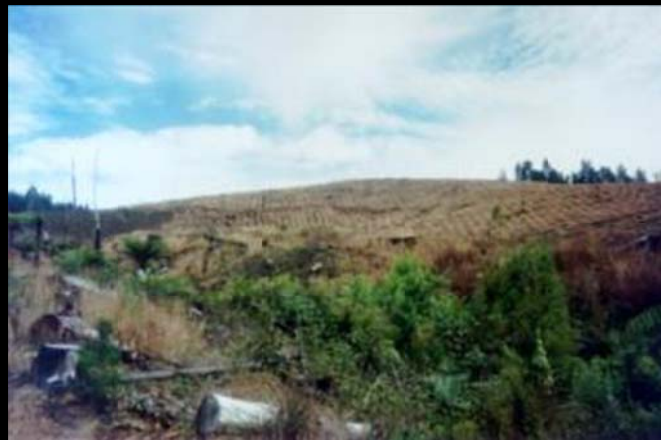
93-48e Feb 01: Gully vegetation. Asplin creek trib. Water from this plantation supplies over 50,000 people with drinking water. Inadequate buffer zones on land that was converted from farmland to plantation.

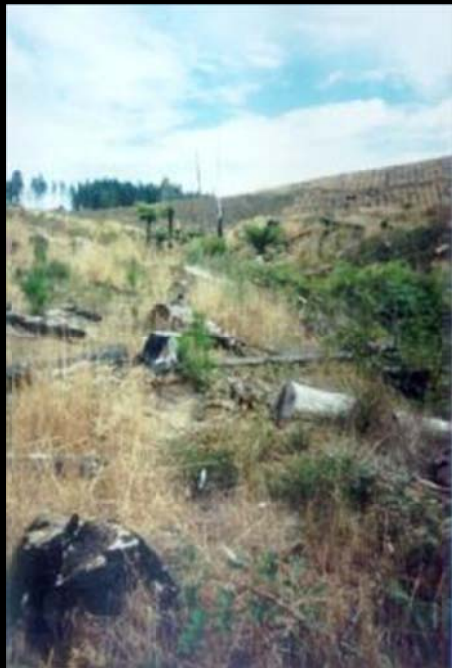
93-48f Feb 01: Gully line replanted with pine. Asplin Creek Trib. Water from this

plantation supplies over 50,000 people with drinking water. Inadequate buffer zones.

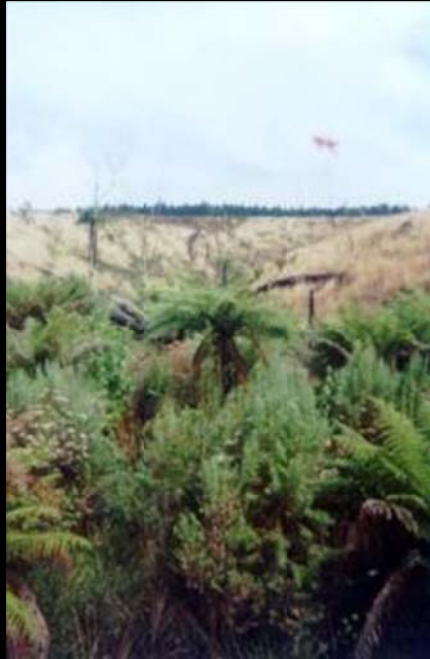
93-48g Feb 01: Gully line - Asplin Creek Trib. Note lack of buffer zones in gully line in background.

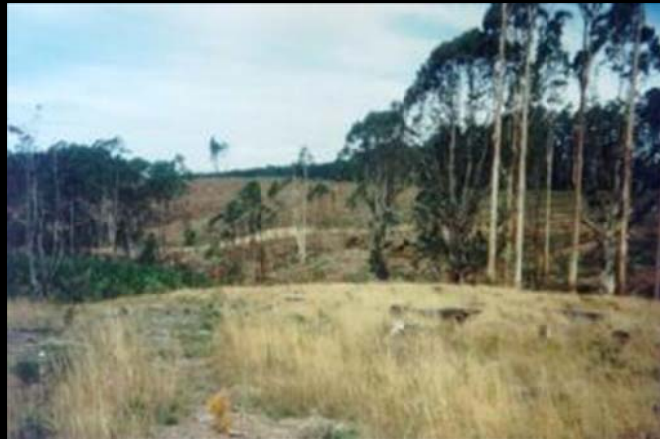
93-48h Feb 01: Gully line - Asplin Creek Trib.

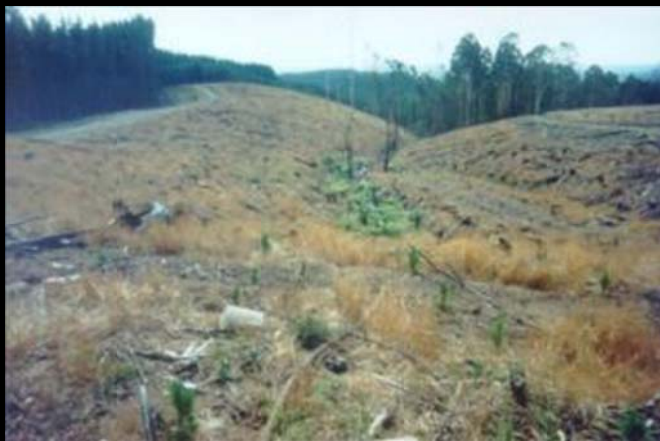
93-48I Feb 01: Gully line - Asplin Creek Trib. Lack of adequate buffer zones in a water

catchment that supplies 50,000 people with drinking water in the states south west.
