**REPORT AND SPECIFICATION  
FOR  
RESTORATION WORKS  
ON NELLIES GLEN ROAD and THE 6 - FOOT TRACK  
NELLIES GLEN**

**Prepared for  
Crown Lands, Parramatta**

DEPARTMENT OF LANDS  
SOIL CONSERVATION SERVICE  
Greater Metropolitan Office  
Level 12, 10 Valentine Ave  
Parramatta NSW 2150

Date: August 2005 Revision No	Author: A.Scott Reviewed by
--	----------------------------------	--------------------------------

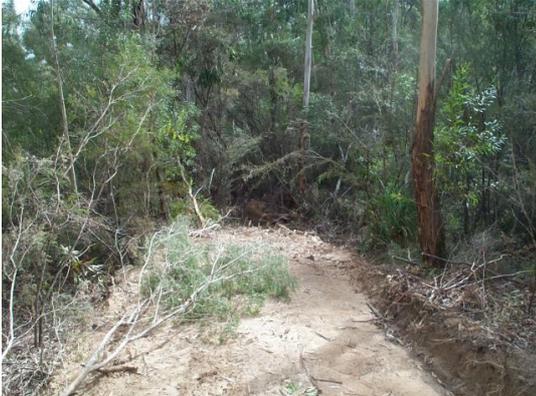
Issue	Remediation	Image	EAST	NORTH
The mitre drain has been extended to far.	Where the mitre drain fall exceeds 5°, the soil will be reformed to create a bank and the disturbed vegetation will be pulled back to protect the soil.  In addition, coir fibre logs will be installed where necessary to trap sediment and slow water flow.

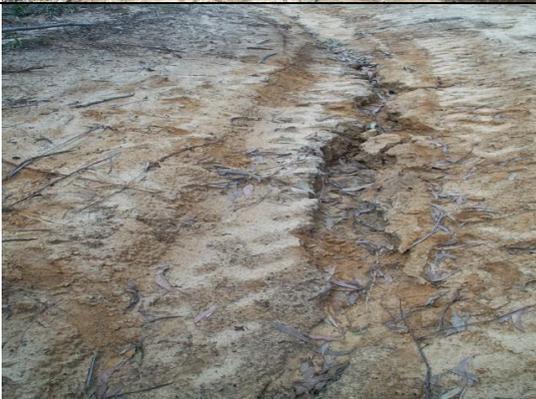
245899.321	6264227.326
The mitre drain has been extended to far.  The fall is too great and erosion is already occurring.	Where the mitre drain fall exceeds 5°, the soil will be reformed to create a bank and the disturbed vegetation will be pulled back to protect the soil.  A rock check dam may be required.  In addition, coir fibre logs will be installed where necessary to trap sediment and slow water flow.

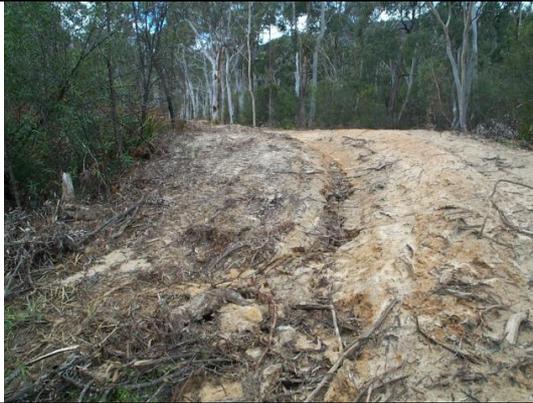
ISSUE	REMEDIATION	IMAGE	EAST	NORTH
<p>Extensive clearing around mitre drains.</p> <p>Fall of drain to great.</p>	<p>Rock checks will be installed to slow water and prevent erosion.</p> <p>Vegetation will be respread and / or brush-matting applied.</p>

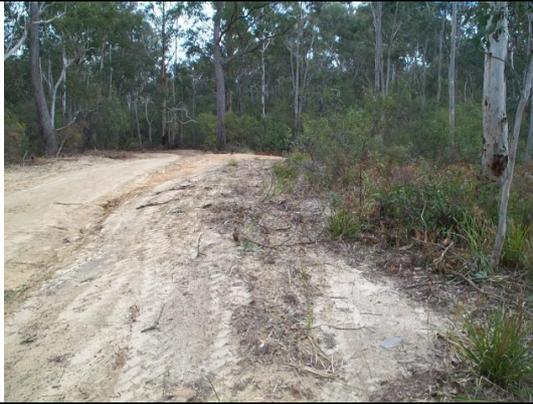
<p>246008.731</p>	<p>6264331.022</p>
<p>Verge cleared</p>	<p>Brush-matting will be installed to protect soil surface.</p>

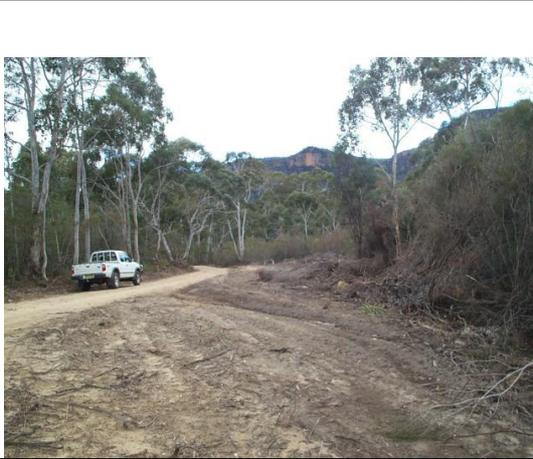
<p>246019.877</p>	<p>6264333.953</p>
<p>Extensive clearing of vegetation during installation of mitre drains</p>	<p>Vegetation and topsoil will be respread and erosion and sediment controls implemented (ie coir fibre logs installed across the slope to intercept water.</p> <p>Brush-matting will be used to cover any remaining bare soil.</p>

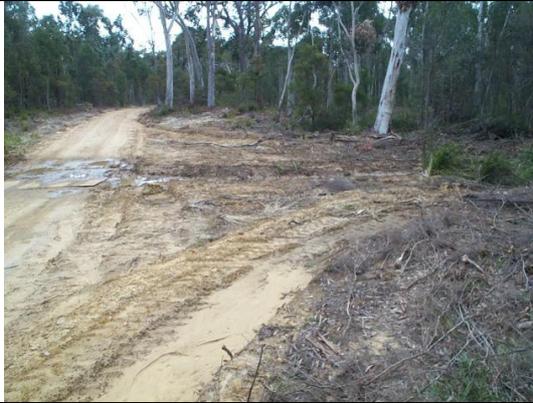
<p>246207.878</p>	<p>6264368.655</p>
<p>Extensive clearing of vegetation around drainage line.</p>	<p>As above</p>
